TECHNICAL REPORT

THE GLACIAL LAKE HANDBOOK

REDUCING RISK FROM DANGEROUS GLACIAL LAKES IN THE CORDILLERA BLANCA, PERU

February 2014

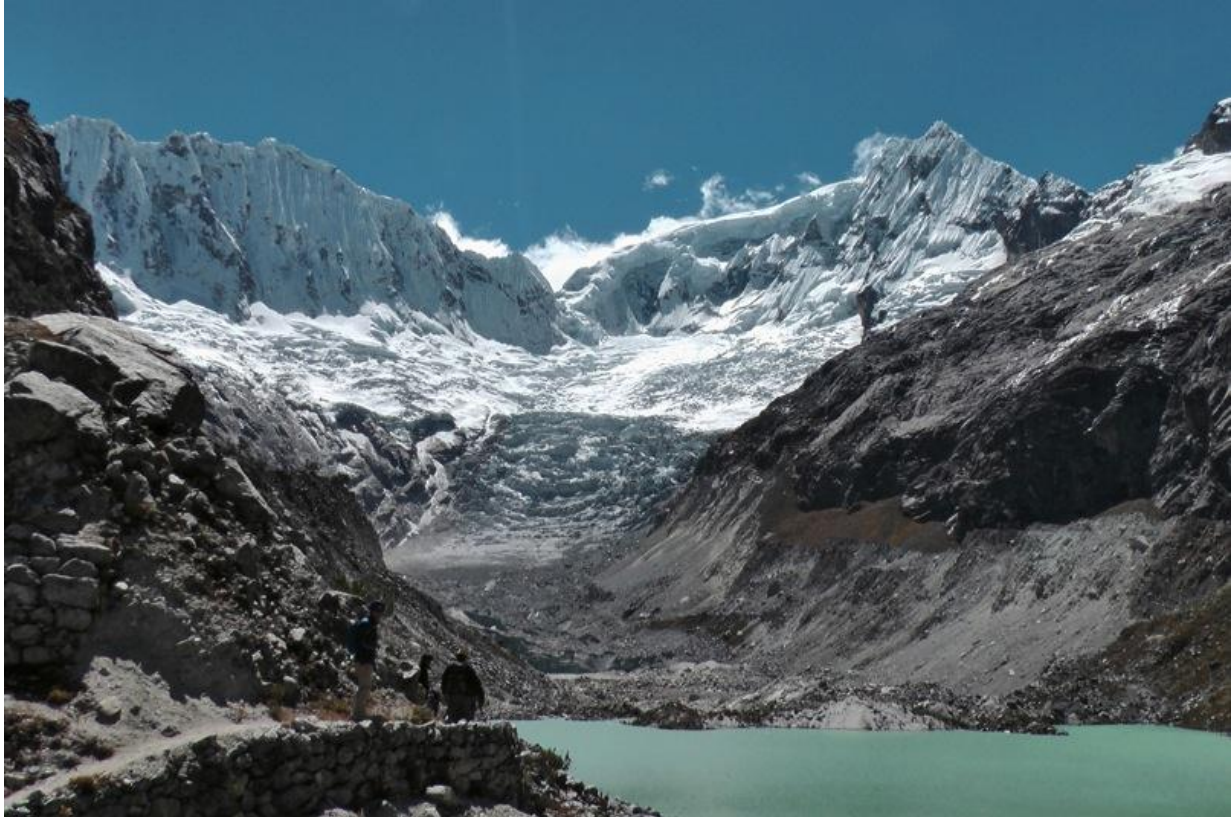
Llica Lake, Huascarán National Park, Peru, is dominated by ice-covered peaks. Large hanging glaciers suspend from the shoulder of the peak on the right (Ranrapalca, 6,162 meters). Flatter, thicker glaciers lie below. As the glacial tongue retreats, it leaves Llica Lake where the glacier used to be. Large icefalls from the tops of these peaks are capable of reaching the lake.

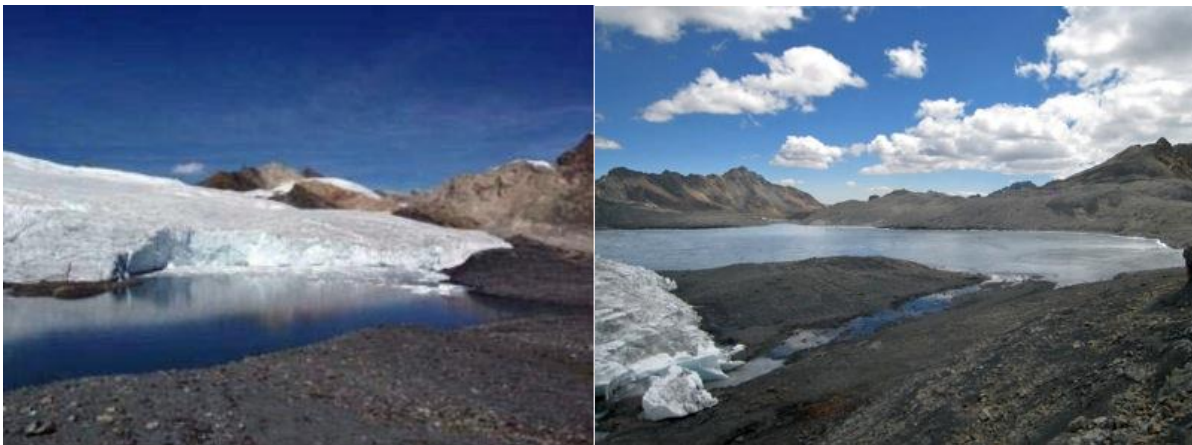
Pastoruri Glacier, Peru, in contact with an emerging lake, showing the calving process. Photos: César Portocarrero (left), Daene McKinney (right)

As glaciers retreat, it often leaves behind empty spaces that are gradually filled with meltwater and eventually form lakes. As these lakes are still in direct contact with the glacier tongue, the temperature difference between the water and the glacier produces an eroding effect that eventually causes the ice to break off and cascade into the lake. This can create a dangerous surge wave, depending on the mass of the ice and the volume and shape of the lake. This phenomenon has caused natural disasters in many places. Examples include the event in [Case Study 5.1: Palcacocha Lake](#), which flooded the city of Huaraz. Also in [Case Study 5.16: Lazo Huntay Lake](#), which flooded the town of Huancayo, and, more recently, in an unnamed lake at the foot of the Nevado Chicón ([see Case Study 5.17: Riticocha Lake](#)).

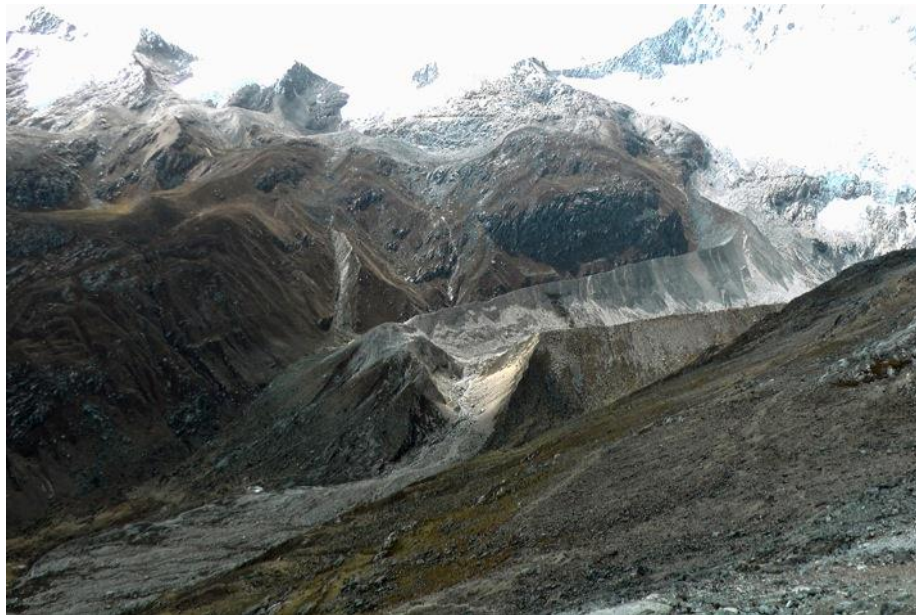
The terminal and lateral moraines that contain Palcacocha Lake, showing the 1941 breach that released a GLOF that devastated the city of Huaraz. Photo taken in 2013. Photo: John Harlin

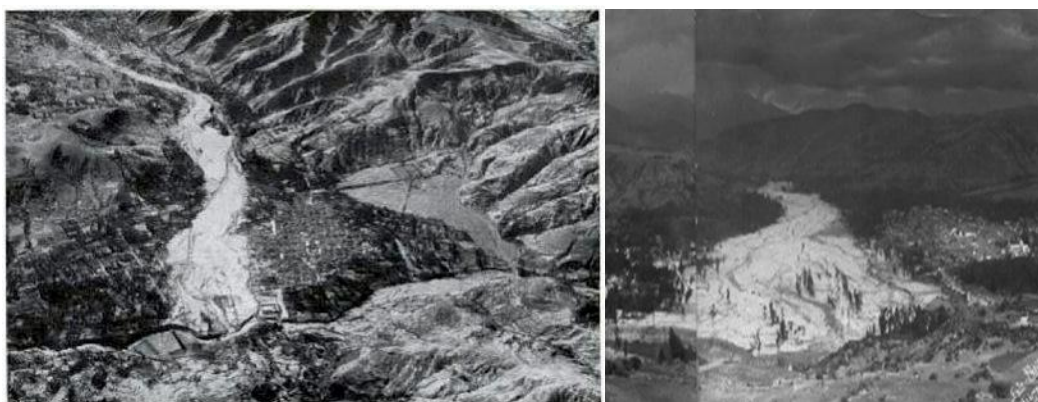
The GLOF's destructive path through the city of Huaraz in 1941. Servicio Aerofotográfico Nacional del Perú

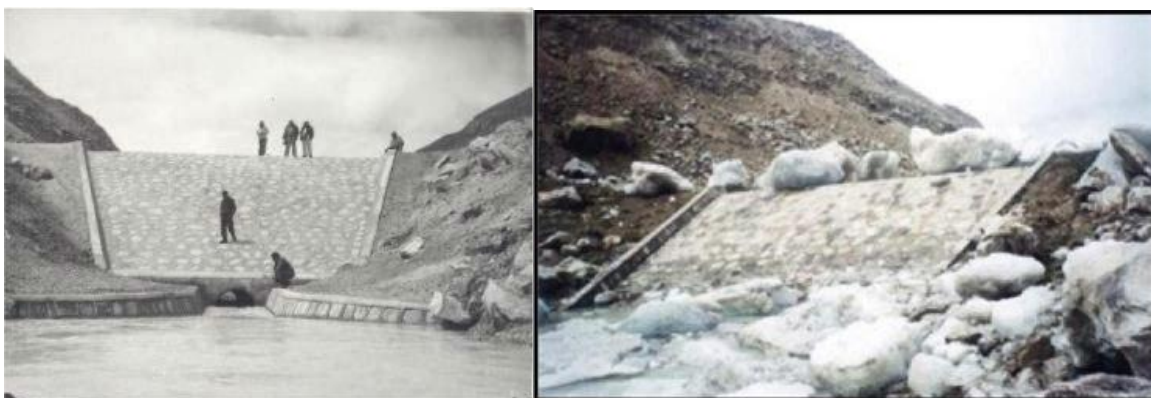
The safety dam on Palcacocha Lake as construction was being completed in 1974 (left) and with ice debris following the 2003 landslide that launched a flood that was mostly contained by the dam. Left photo: César Portocarrero. Right: Glaciology Unit Office Archives

At that time the Lakes Safety and Glaciology Unit decided to lower the lake's level by one meter, which they concluded was enough based on its low volume of 500,000 m³. In 1974, they installed a 48 inches (1,219 millimeters) diameter steel pipe capped by a new, tightly compacted dirt dam 8 meters high. They also strengthened the right side of the moraine outflow to reduce erosion from outbursts. This provided a freeboard of 8 meters in the lake as a buffer against future surge waves.

Nineteen years later, in March 2003, the moraine along the lake's left flank slipped, launching a violent diagonal wave that traversed the lake and heavily eroded the reinforced dam. Photographs, taken five days after the 2003 event, show chunks of ice still sitting on the 8-meter dam, and water levels still 4 meters above its normal level. This event frightened the Huaraz city authorities. The regional government quickly repaired the damaged structures.

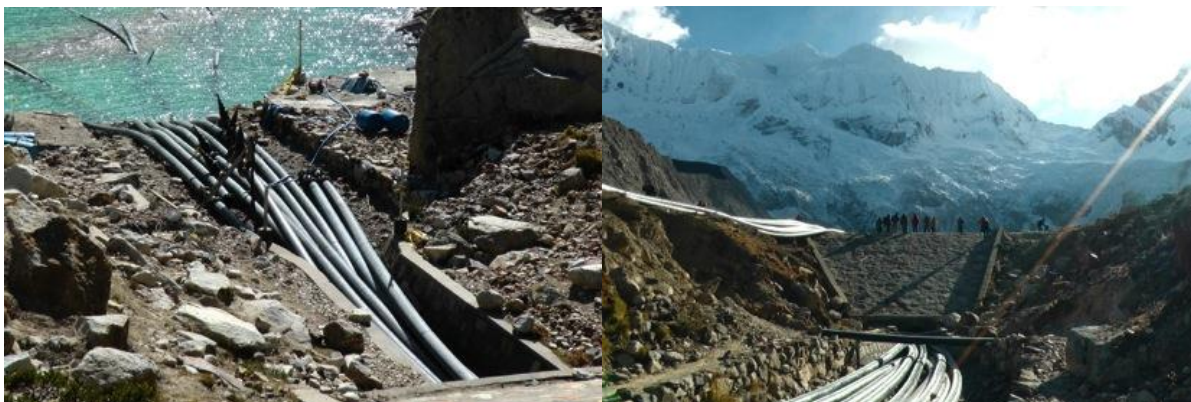
Palcacocha Lake in 2013 showing the siphon pipes entering (left) and exiting the tunnel under the dam. Photos: John Harlin

The Glaciology and Water Resources Unit prepared a plan in 2010 to lower the water level of Palcacocha Lake by an additional 15 meters. The cost estimate for this work came in at US\$4 million. Later in 2010, Peru's National Water Authority unexpectedly relieved the Glaciology and Water Resources Unit from responsibility for glacial lakes and turned the lake-lowering plan over to the regional government in Ancash. Ancash officials did not think they could authorize these funds quickly, so they searched for an interim, cheaper way to reduce risk from the lake. They decided to use six 10-inch (254 millimeters)-diameter pipes about 700 meters long to siphon off approximately 7 million cubic meters of water. Two years later (in 2011), the siphons started draining the lake though at a slower rate than planned due to design defects. As of July 2013, the water level had been lowered approximately 3 meters, roughly half the amount needed before the drainage ditch can be started.

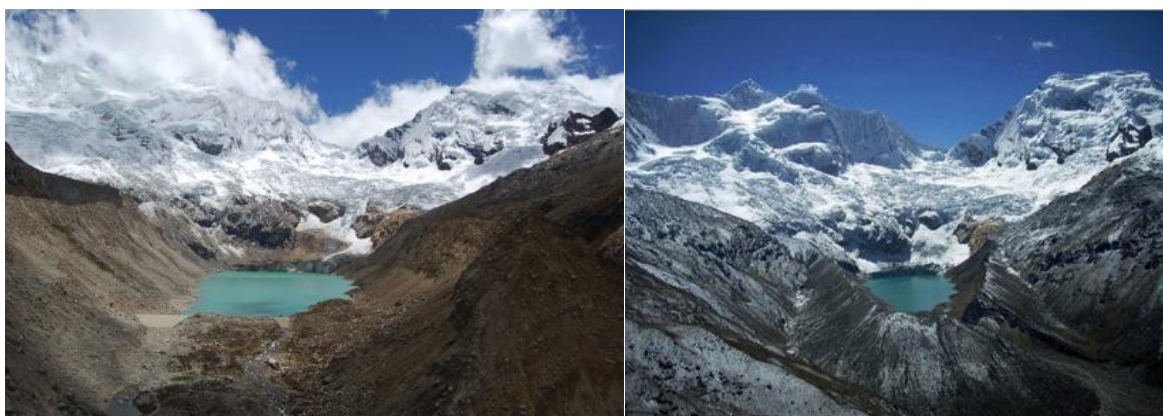
Left: Palcacocha Lake in 2013 taken from the top of the moraine. The two safety dams can be seen. The dam on the right contains the drainage pipes. Photo: César Portocarrero. Right: Palcacocha Lake in 2008 showing its enclosing moraine; the 1941 breach is visible in the lower right. Photo: Colette Simonds

In an effort to mitigate the risk of the lake, two 36 inches (915 millimeters) steel pipes were placed in the notch that had been cut into the moraine by the GLOF. Then, an 8-meter rammed earth dam was built over the top. These safety works continued working properly until the May 31, 1970, earthquake (magnitude 7.9) destroyed the dam's foundations, breaking the drainpipes installed underneath.

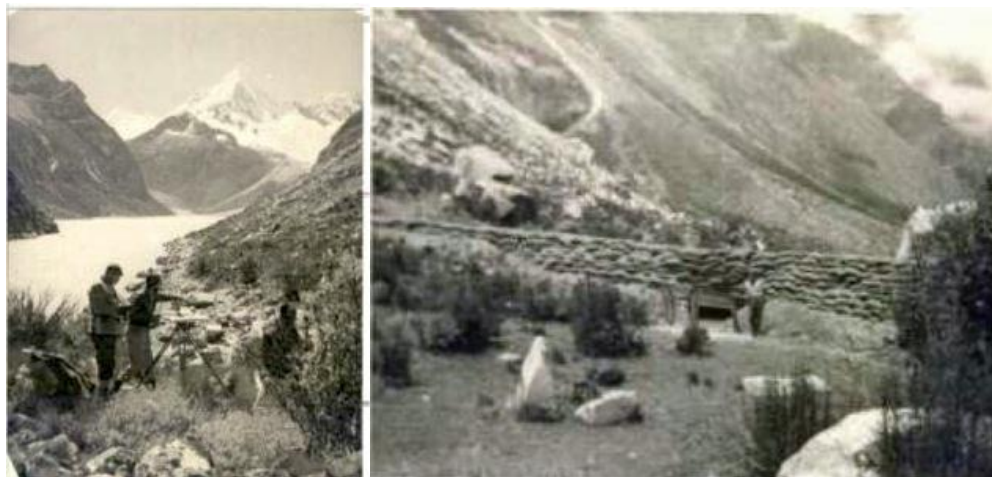
1951 photos of surveyors and a sand bag dam built as a temporary barrier below Lake Parón. Photos: Glaciology Unit Office Archives

Some safety measures were implemented after the 1951 outburst floods from Lake Artesoncocha including placing sand bags over the natural dam. Topographical studies examined lake characteristics for future drainage projects.

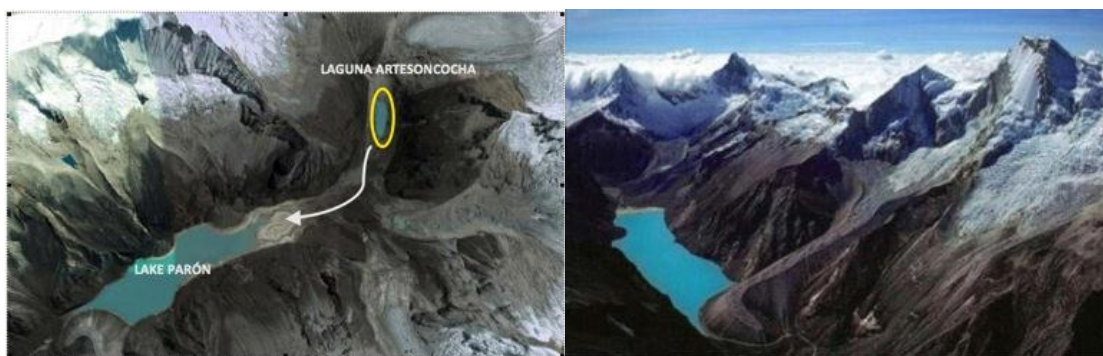
Left: The path taken by the 1951 outburst floods from Artesoncocha into Lake Parón. Google Earth imagery is from 2012. Right: Lake Parón showing the moraine descending from Huandoy that blocked the valley and created the lake. Photo: César Portocarrero

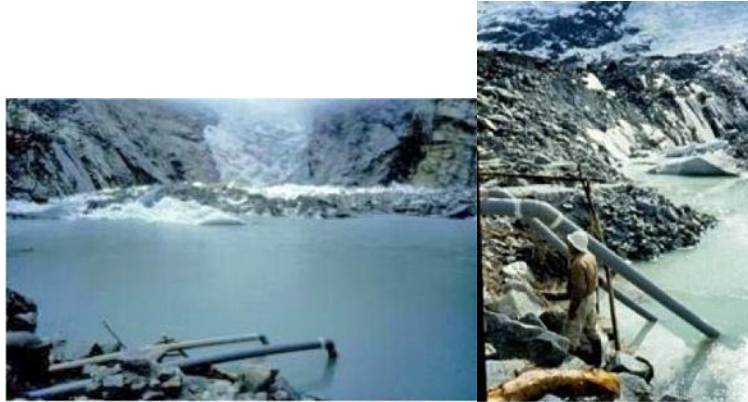
The initial siphoning process to lower the water level of Lake 513 in the late 1980s. Siphoning was an interim measure until funding was received for construction of the tunnel. Photos: César Portocarrero

The remoteness of the area and the lack of resources available for a major project led the Glaciology Unit to install temporary siphons in 1989 (with financial support from the British and Austrian governments). These plastic pipes, 10 inches (254 millimeters) and 12 inches (305 millimeters) in diameter, were used to lower the water level by about 6 meters. In 1992, drilling started for a tunnel that would lower the water level by 20 meters. The work was financed by the Peru's Civil Defense Institute.

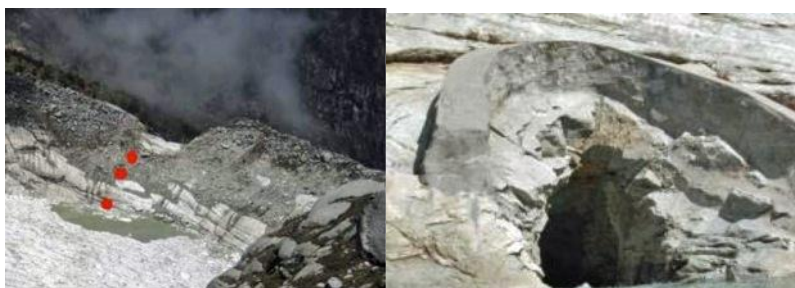
Red dots mark the tunnel entrances on Lake 513. The photo on the right shows the lowest entrance. Photos: César Portocarrero

The original plan was for the tunnel to contact the lake at a depth of 20 meters, using underwater blasting and placing devices inside the tunnel to regulate the outflow. However, this plan was abandoned during construction when the driller became afraid to blast the connection to the lake at such a depth. Instead, a sloping shaft was built from which connections would be added at increasing depths of 5, 10, 15, and 20 meters.

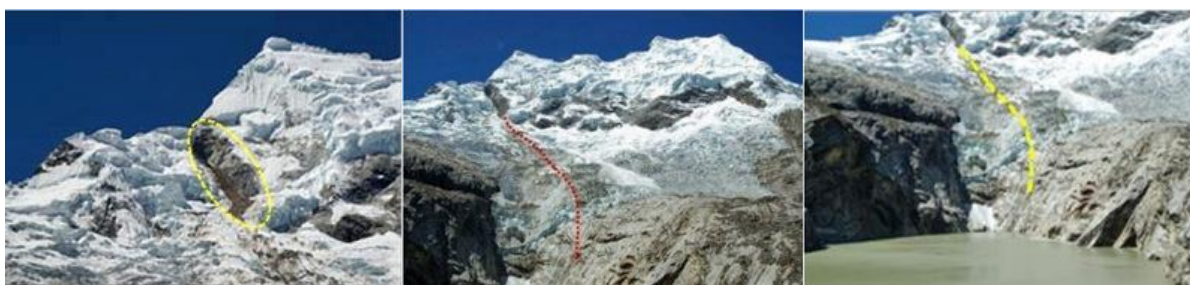
The source and path of the 2010 ice avalanche from Hualcán that fell into Lake 513. There is potential for many more such avalanches. Photos: César Portocarero

During the ensuing 18 years, the combined drainage tunnel and freeboard fulfilled the mission to regulate the flow produced by moderate avalanches from Mt. Hualcán. Then, on 11 April 2010, a very large avalanche, presumably in the 300,000 to 400,000 m³ range, caused a hydrodynamic surge and a wave higher than 20 meters that overflowed the works and flooded the Chucchun River for approximately 30 hours, destroying bridges, farmland, and houses.

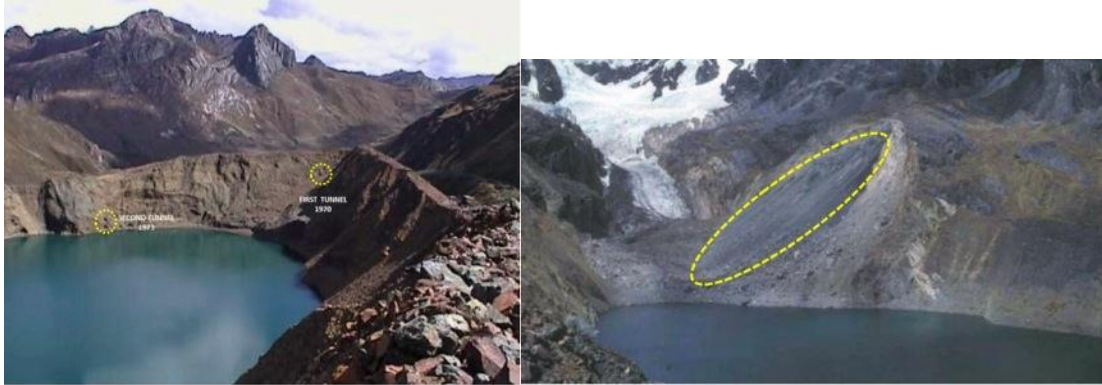
Safuna Alta Lake. Left: Locations of the two tunnels drilled into the moraine in the early 1970s as the lake's level dropped on its own. Right: The source of the landslide in 2002 that launched a wave at least 80 meters in height. Photos: César Portocarrero (1974)

History of work: In the early 1960s the Glaciology Unit recommended building a 47-meter-long drainage tunnel that would prevent the lake's water level from rising above 4,360 meters. In April 1970, a tunnel was completed that was supposed to reduce the water level by 38 meters (Ames and Francou, 1995). However, by then the water level had dropped by 30 meters, so that the tunnel was above the lake's new water level. A month later, a large earthquake severely damaged the tunnel. A new 159-meter-long tunnel was built that, like the previous tunnel, had to be excavated through morainic material. (Report of the Glaciology and Lake Control Office of the Corporation Peruana del Santa, 1972).

In 2002, a rockslide created a wave of at least 80 meters in height (Reynolds, 2003). The wave damaged both tunnels, but did not destroy the moraine.

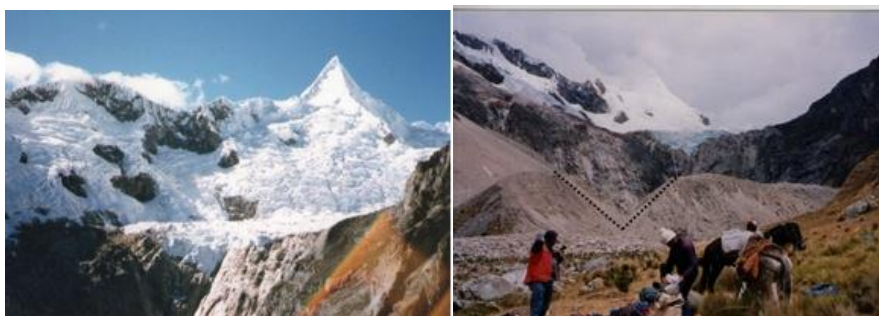
Left: Alpamayo Peak (5947 m), perhaps the most iconic peak of the Cordillera Blanca; Jancarurish Lake sits below the visible glacial tongue. Right: The V-shape cut into Jancarurish Lake's moraine in 1951. Photos: César Portocarrero (1990)

Conclusions: Open pit cuts through moraines are risky because the cut is especially vulnerable to erosion before pipes and reinforcements are added. Early engineering works in the Cordillera Blanca did not have the benefit of today's knowledge, including the use of important safety measures, such as early warning systems. Today, temporary early warning systems should be installed as a precaution against possible unforeseen events, including ice avalanches.

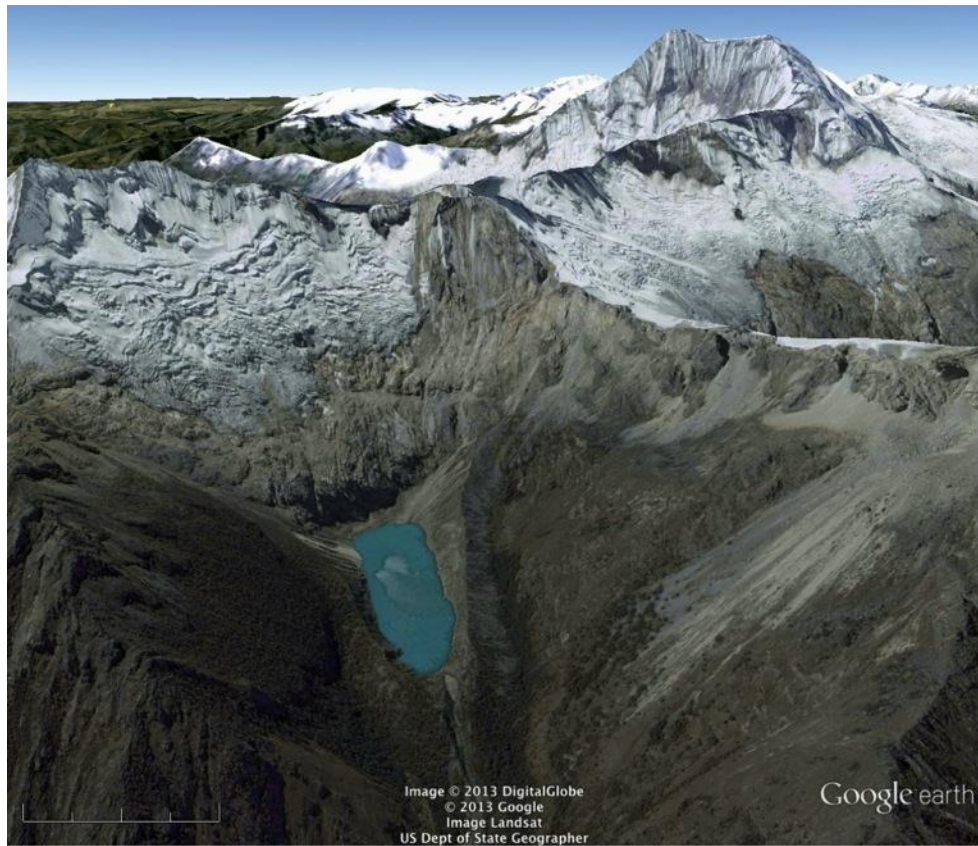
Huallecacocha Lake with its safety dam visible lower right.

Risk: After the earthquake of May 31, 1970, old geological, glaciological, and topographic studies were updated throughout the Cordillera Blanca. They indicated that, because of the volume of stored water in Huallecacocha Lake, damage to the lake's inner slope and settlement within the 1960s-era safety structure necessitated additional security works. The risk was greatly magnified by hanging glaciers above. The Studies Division of the Glaciology Unit recommended extensive new safety works.

History of work: This lake was treated twice. In the 1960s the former Control Bureau of Cordillera Blanca Lakes lowered its water level by 10 meters, and then built a sluice of stone masonry one square meter in cross section and 102 meters long. A 10-meter-high artificial dam, stabilized by riprap, was built on top of the structure.

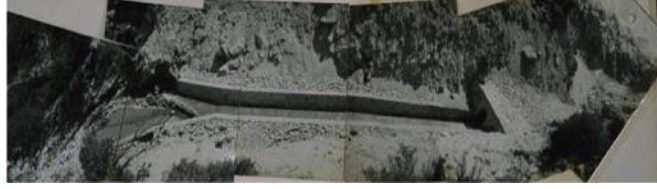
Safety works on Huallecacocha Lake: 1950s construction (top) and the finished result in the 1960s. Photos: Glaciology Office Archives

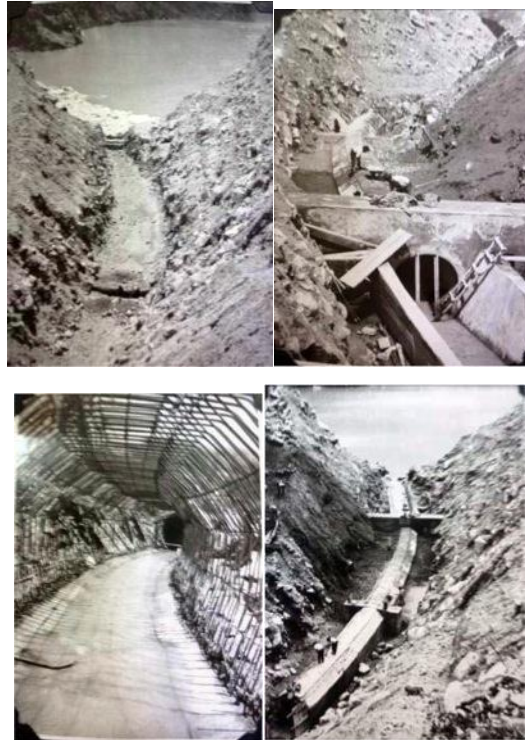
New tunnel being constructed in the early 1980s. First the channel was cut, then the tunnel built, and finally the canal was covered with a safety dam. Photos: César Portocarrero

New work following the 1970 earthquake required completely removing the original 20-year-old construction. The lake was then lowered by 14 meters through an open pit at the front of the moraine. The next phase involved building a reinforced concrete pipe 1.8 meters in diameter and 77 meters in

length. Inflow and outflow canals were built of stone masonry. To prevent soil erosion by water exiting the conduit at high velocity, a fast exit waterway of reinforced concrete and an energy sink were added. Finally, to contain potential surge waves resulting from ice masses falling into the lake, a 20-meter-high earth dam with an impervious waterproof core was added. The outside walls were finished with stone masonry sealed with cement mortar. During construction a mass of ice fell into the lake, but did not damage the work that was underway.

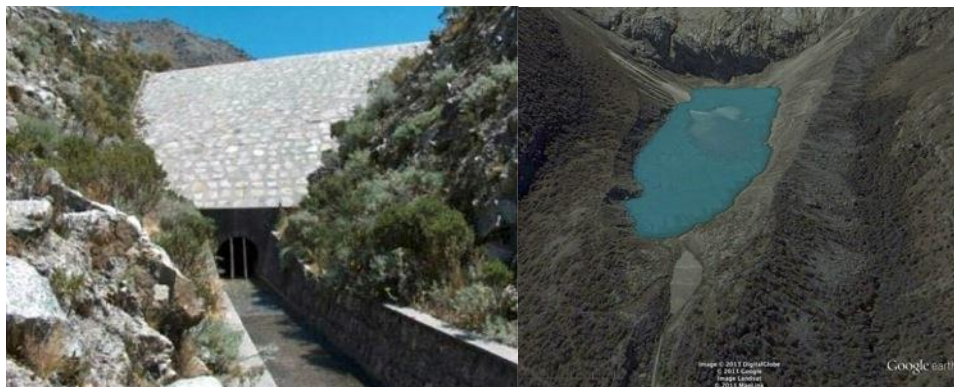
Huallecacocha's completed safety dam from below (1978) and above (2013). Photo: César Portocarrero

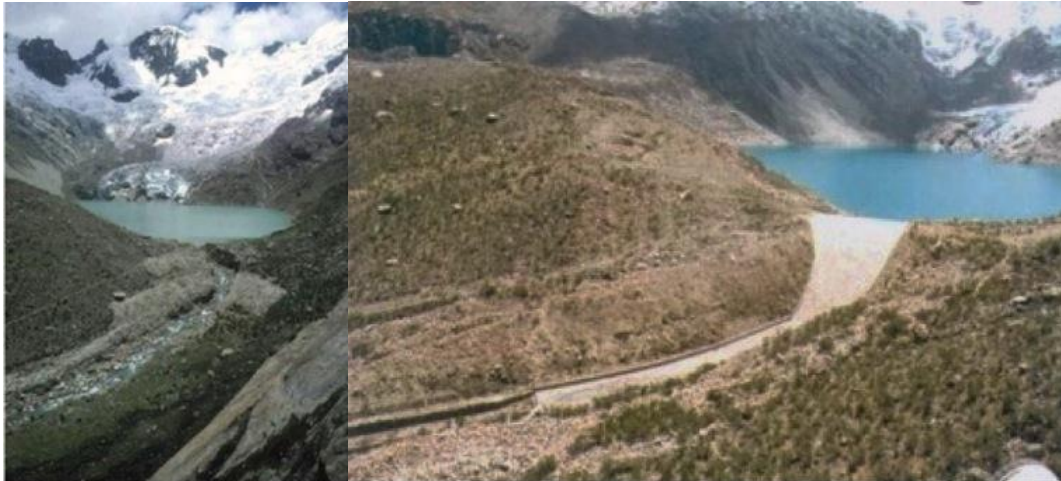
Paccharruri Lake showing the sluice cut to lower the water level (left) and the completed safety dam and outflow canal beyond the covered sluice. Photos: César Portocarrero

Work began in the early 1980s to lower the level of the water surface by 10 meters. A covered sluice 71 meters long and 1.8 meters in diameter was built, over which an 18-meter-high safety dam was added. As in other works of the same type, covered access and exit conduits were built to prevent erosion of the moraine material and safely move water downstream.

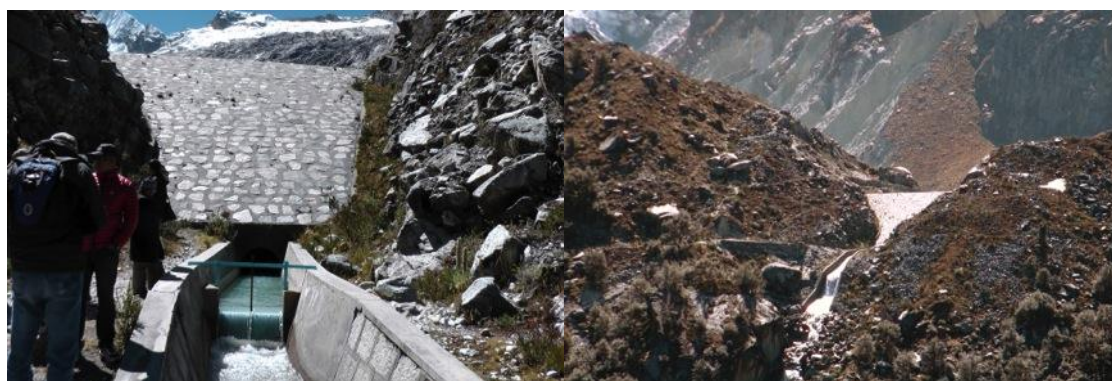
Llaca Lake's safety dam and sluice in 2013. Photos: John Harlin

History of work: First, steps were taken to improve access roads and camp sites. Once these improvements were finished, engineers lowered the lake by 10 meters through an open pit cut. After the lake was lowered, a 48-inch(1,219 millimeter)-diameter steel pipe was installed. When completed in 1974, the lake's maximum depth was 19 meters.

From 1976 to 1977, the second stage of the project involved building a 10-meter-high earth dam inside the open pit cut (on top of the steel pipes), with an impermeable core and stone walls finished with cement mortar-sealed joints.

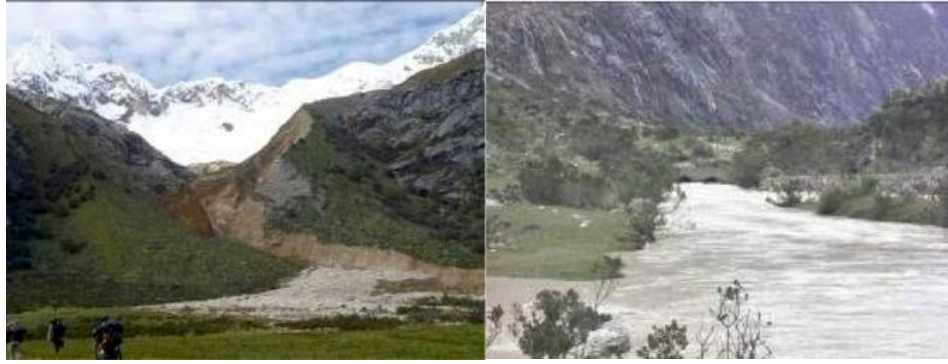
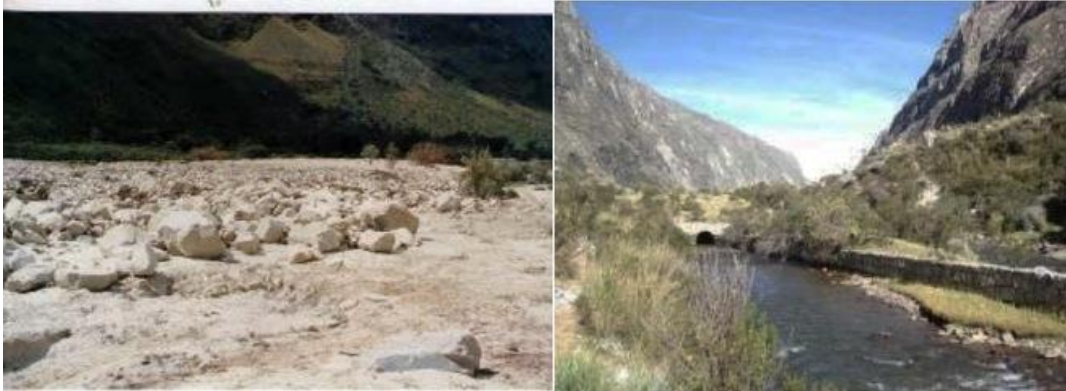
Top left: The path cut through Artizon Lake's moraine during its 2012 GLOF. Top right: Floodwaters resulting from Artizon's GLOF almost filled the drain pipes under Jatuncocha's dam. Bottom left: Debris from the 2012 Artizon GLOF. Bottom right: Relatively normal flows through the Jatuncocha tunnels. Photos: César Portocarrero

Although the Jatuncocha dam contained the flood, the flow through the two pipes reached more than 10 cubic meters per second down the steep valley below, causing substantial erosion and destruction of homes, property, and roads.

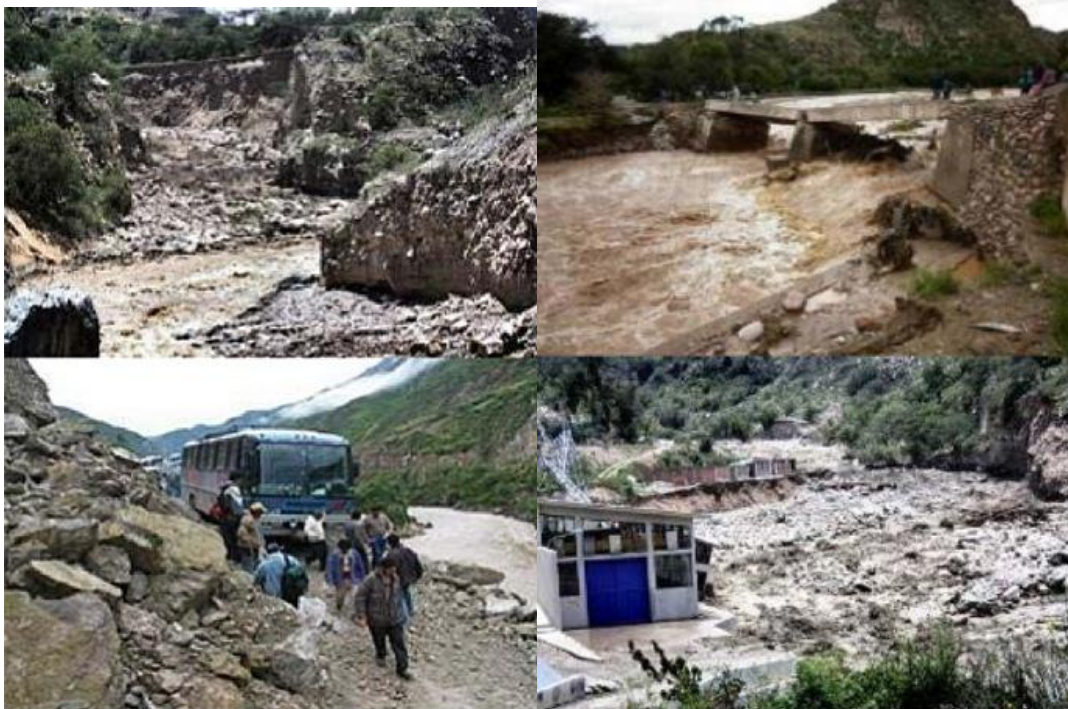
Damage in the Santa Cruz valley downstream from Jatuncocha during the 2012 GLOF. Photos: Hidroeléctrica Santa Cruz

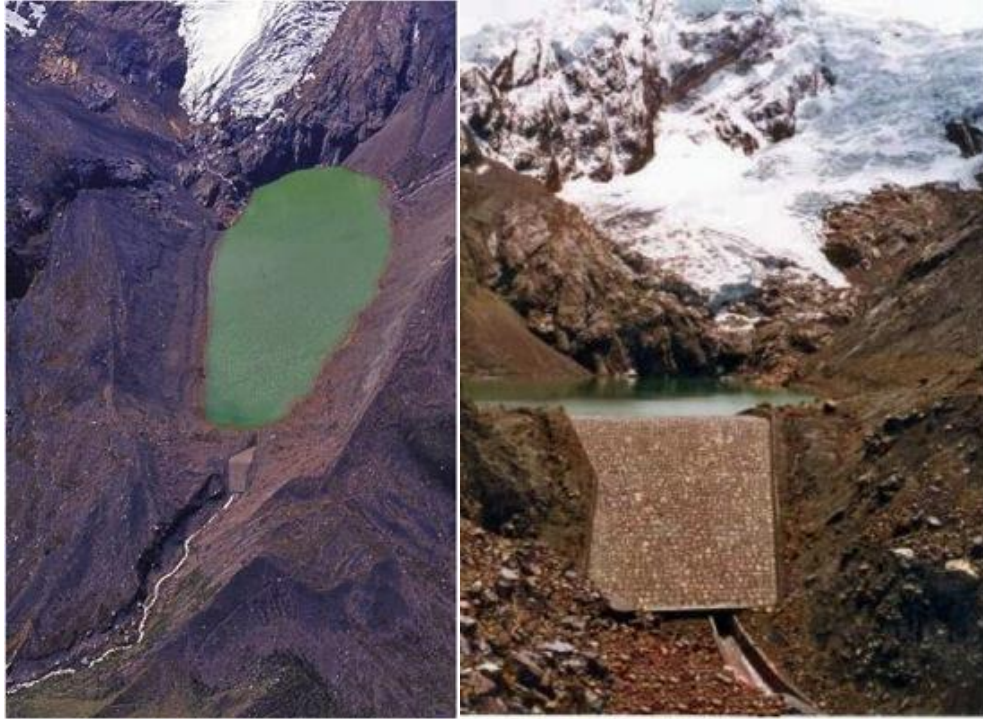
Aerial and ground views of Cuchillacocha Lake's dam, completed in 1974. Right photo: César Portocarrero

Given the low existing dam (4 meters tall), the Glaciology Unit built additional safety works. The first step was to lower the lake's surface level by 10 meters, which entailed evacuating about 1.6 million m³ of water. Next, they built a covered conduit and over it erected a 16-meter-high earth dam to contain future wave surges from ice avalanches. Inflow and outflow canals were added for the covered duct. In addition, they built bridle paths and semi-permanent camps for field workers. The work was completed in 1974.

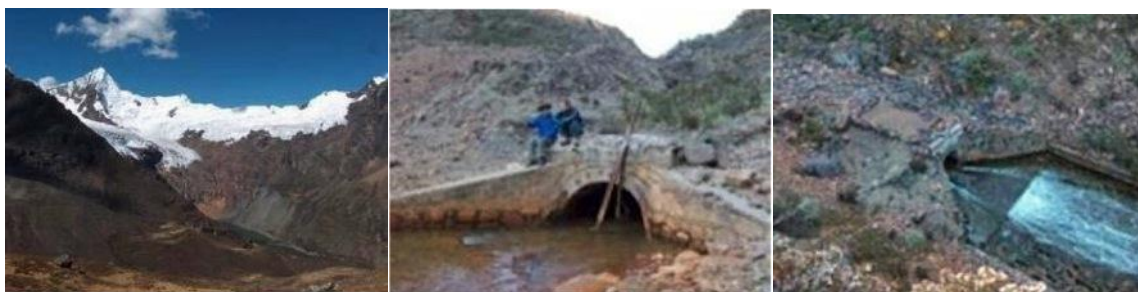
Tullparraju Lake showing its steep flanks and the hanging glacier above. Middle and right photos show the entrance and exit of the drainage tunnel. All photos from 1974: César Portocarrero

History of work: A threat to Huaraz, Tullparaju was among the first lakes to be treated following the 1941 flood from Palcacocha. In 1942, the lake's surface level was lowered by 18 meters with a V-shaped open cut. In addition to the open cut, a tunnel was drilled into the moraine so the lake wouldn't rise.

Over the years the tunnel developed numerous leaks, which prompted the Glaciology Unit to strengthen the drainage tunnel with concrete in 1974. The Unit also built a reinforced 10-meter-high earth dam above the tunnel to counteract possible glacier wave surges caused by avalanches or landslides.

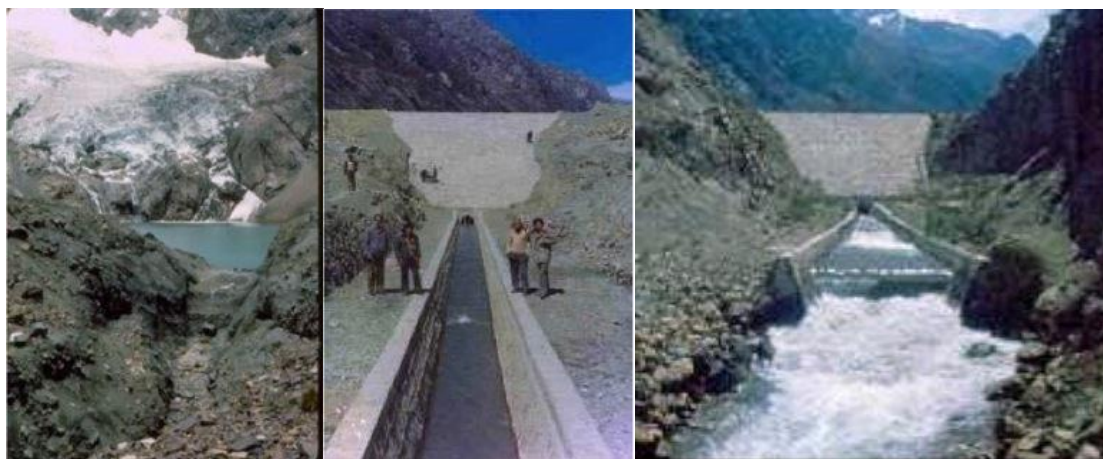
Constructing the Shallap Lake safety dam and water channel in 1973 and the completed work in 1974. Photos: César Portocarrero

History of work: Shallap Lake's water level was lowered 8 meters in 1948. In 1951, two 42-inch(1,067 millimeter)-diameter steel pipes were installed to drain the lake. A 4-meter earth dam was added in 1952. After the 1970 earthquake, studies determined the lake to be 720 meters long and 320 meters wide,

holding 4.7 million m³ of water. The natural dam consisted of two high lateral moraines and a lower terminal moraine where the 4-meter-high dam had been built. In 1972–1974 the Glaciology Unit lowered the water surface by 10 meters and built an 80-meter-long covered passage, including a steel pipe beneath an earth dam and masonry channels. As in other cases, the artificial dam was built with a waterproof core and masonry walls.

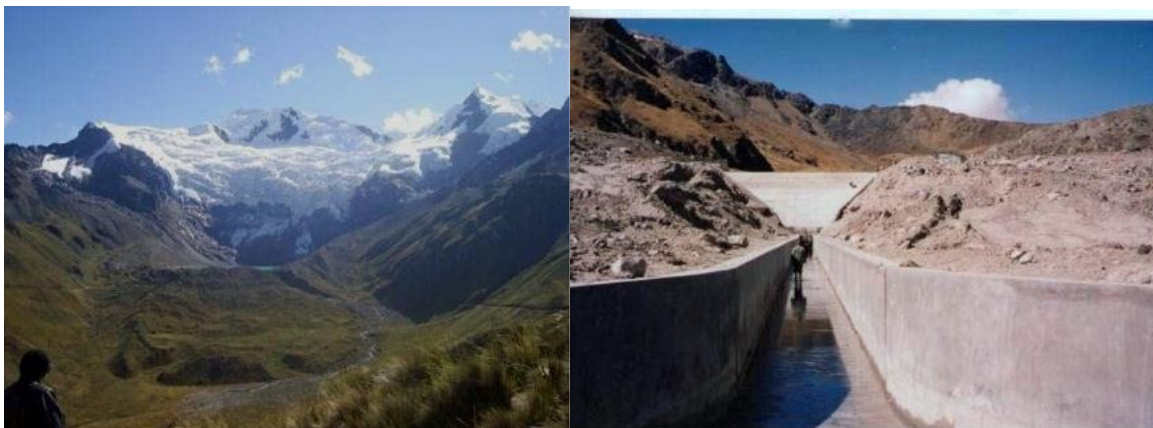
Lazo Huntay Lake showing the still-massive hanging glacier in 1990, and the newly completed safety works in 1990. Photos: César Portocarrero

In 1977, the Glaciology Unit initiated work (with support from The National Institute of Civil Defense of Peru) to partially drain the lake. Then, in early 1990, the Glaciology Unit recommenced work to complete the project by further lowering the water level, building an exhaust duct, and installing a dam.

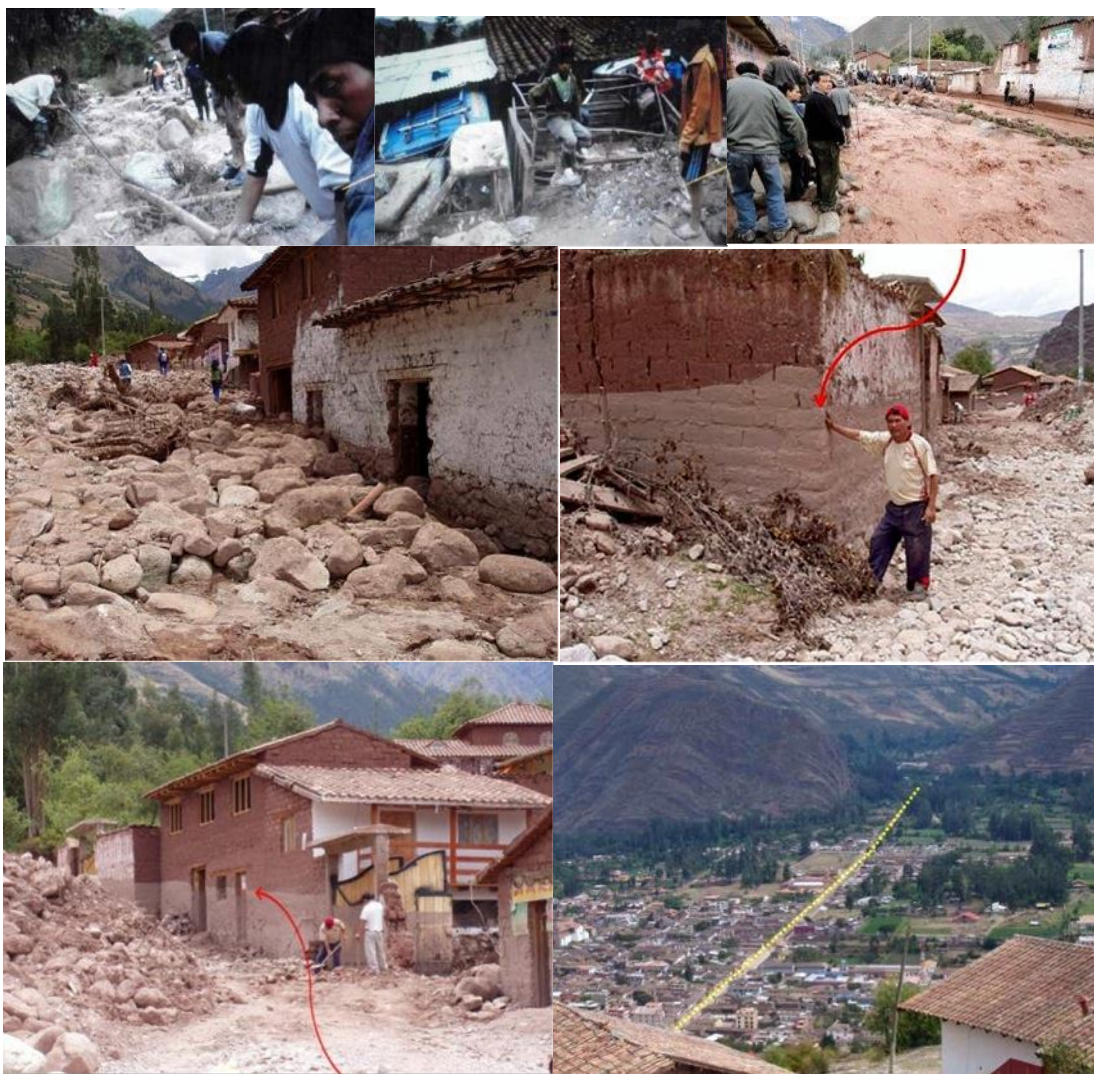
Top row: Photos from the flood of the Chicón River in San Isidro and Urubamba resulting from the Riticocha GLOF on 17 October 2010. Middle row: Debris and flood lines on walls in Urubamba in 2010. Lower right: The path the Chicón River took through Urubamba in 2010. Top row photos: Municipality of Urubamba. Other photos: César Portocarrero

On October 17, 2010, a large flash flood of the Chicón River damaged small towns as the water descended to the city of Urubamba. Investigations revealed that the flash flood was a GLOF from a new lake that had appeared at the foot of the Chicón Glacier: Riticocha Lake. Videos taken from helicopters revealed blocky fragments of ice on rock walls near the lake, indicating that one or more large waves had deposited them. It appeared that an original mass of water had triggered a second, lower lake to also be partially emptied.

Such heavy destruction leads scientists from the Cusco Civil Defense to believe that the volume of the GLOF was larger than the volume of the present lake. Clues include the magnitude and size of transported rocks, the volume of debris, and the boulders that reached the town of Urubamba. The floodwater's destructive power was increased by recent road building activities. Construction had loosened the earth and construction debris, including broken tree trunks, had been dumped into the riverbed.

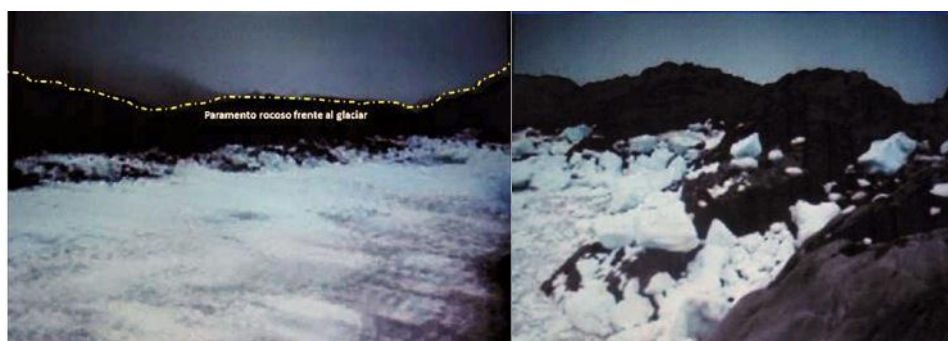
Waves deposited these large ice fragments high on Riticocha's rock walls. These photographs were taken a few days after the event and were taken during daylight, but are dark because it was captured from video. The dashed yellow line indicates the edge of the glacier. Photos: Urubamba Civil Defense
